## **WASTE MANAGEMENT PLAN**

## **Alexan – Fashion Valley Project**

San Diego, California Project No. 474586

April 2016

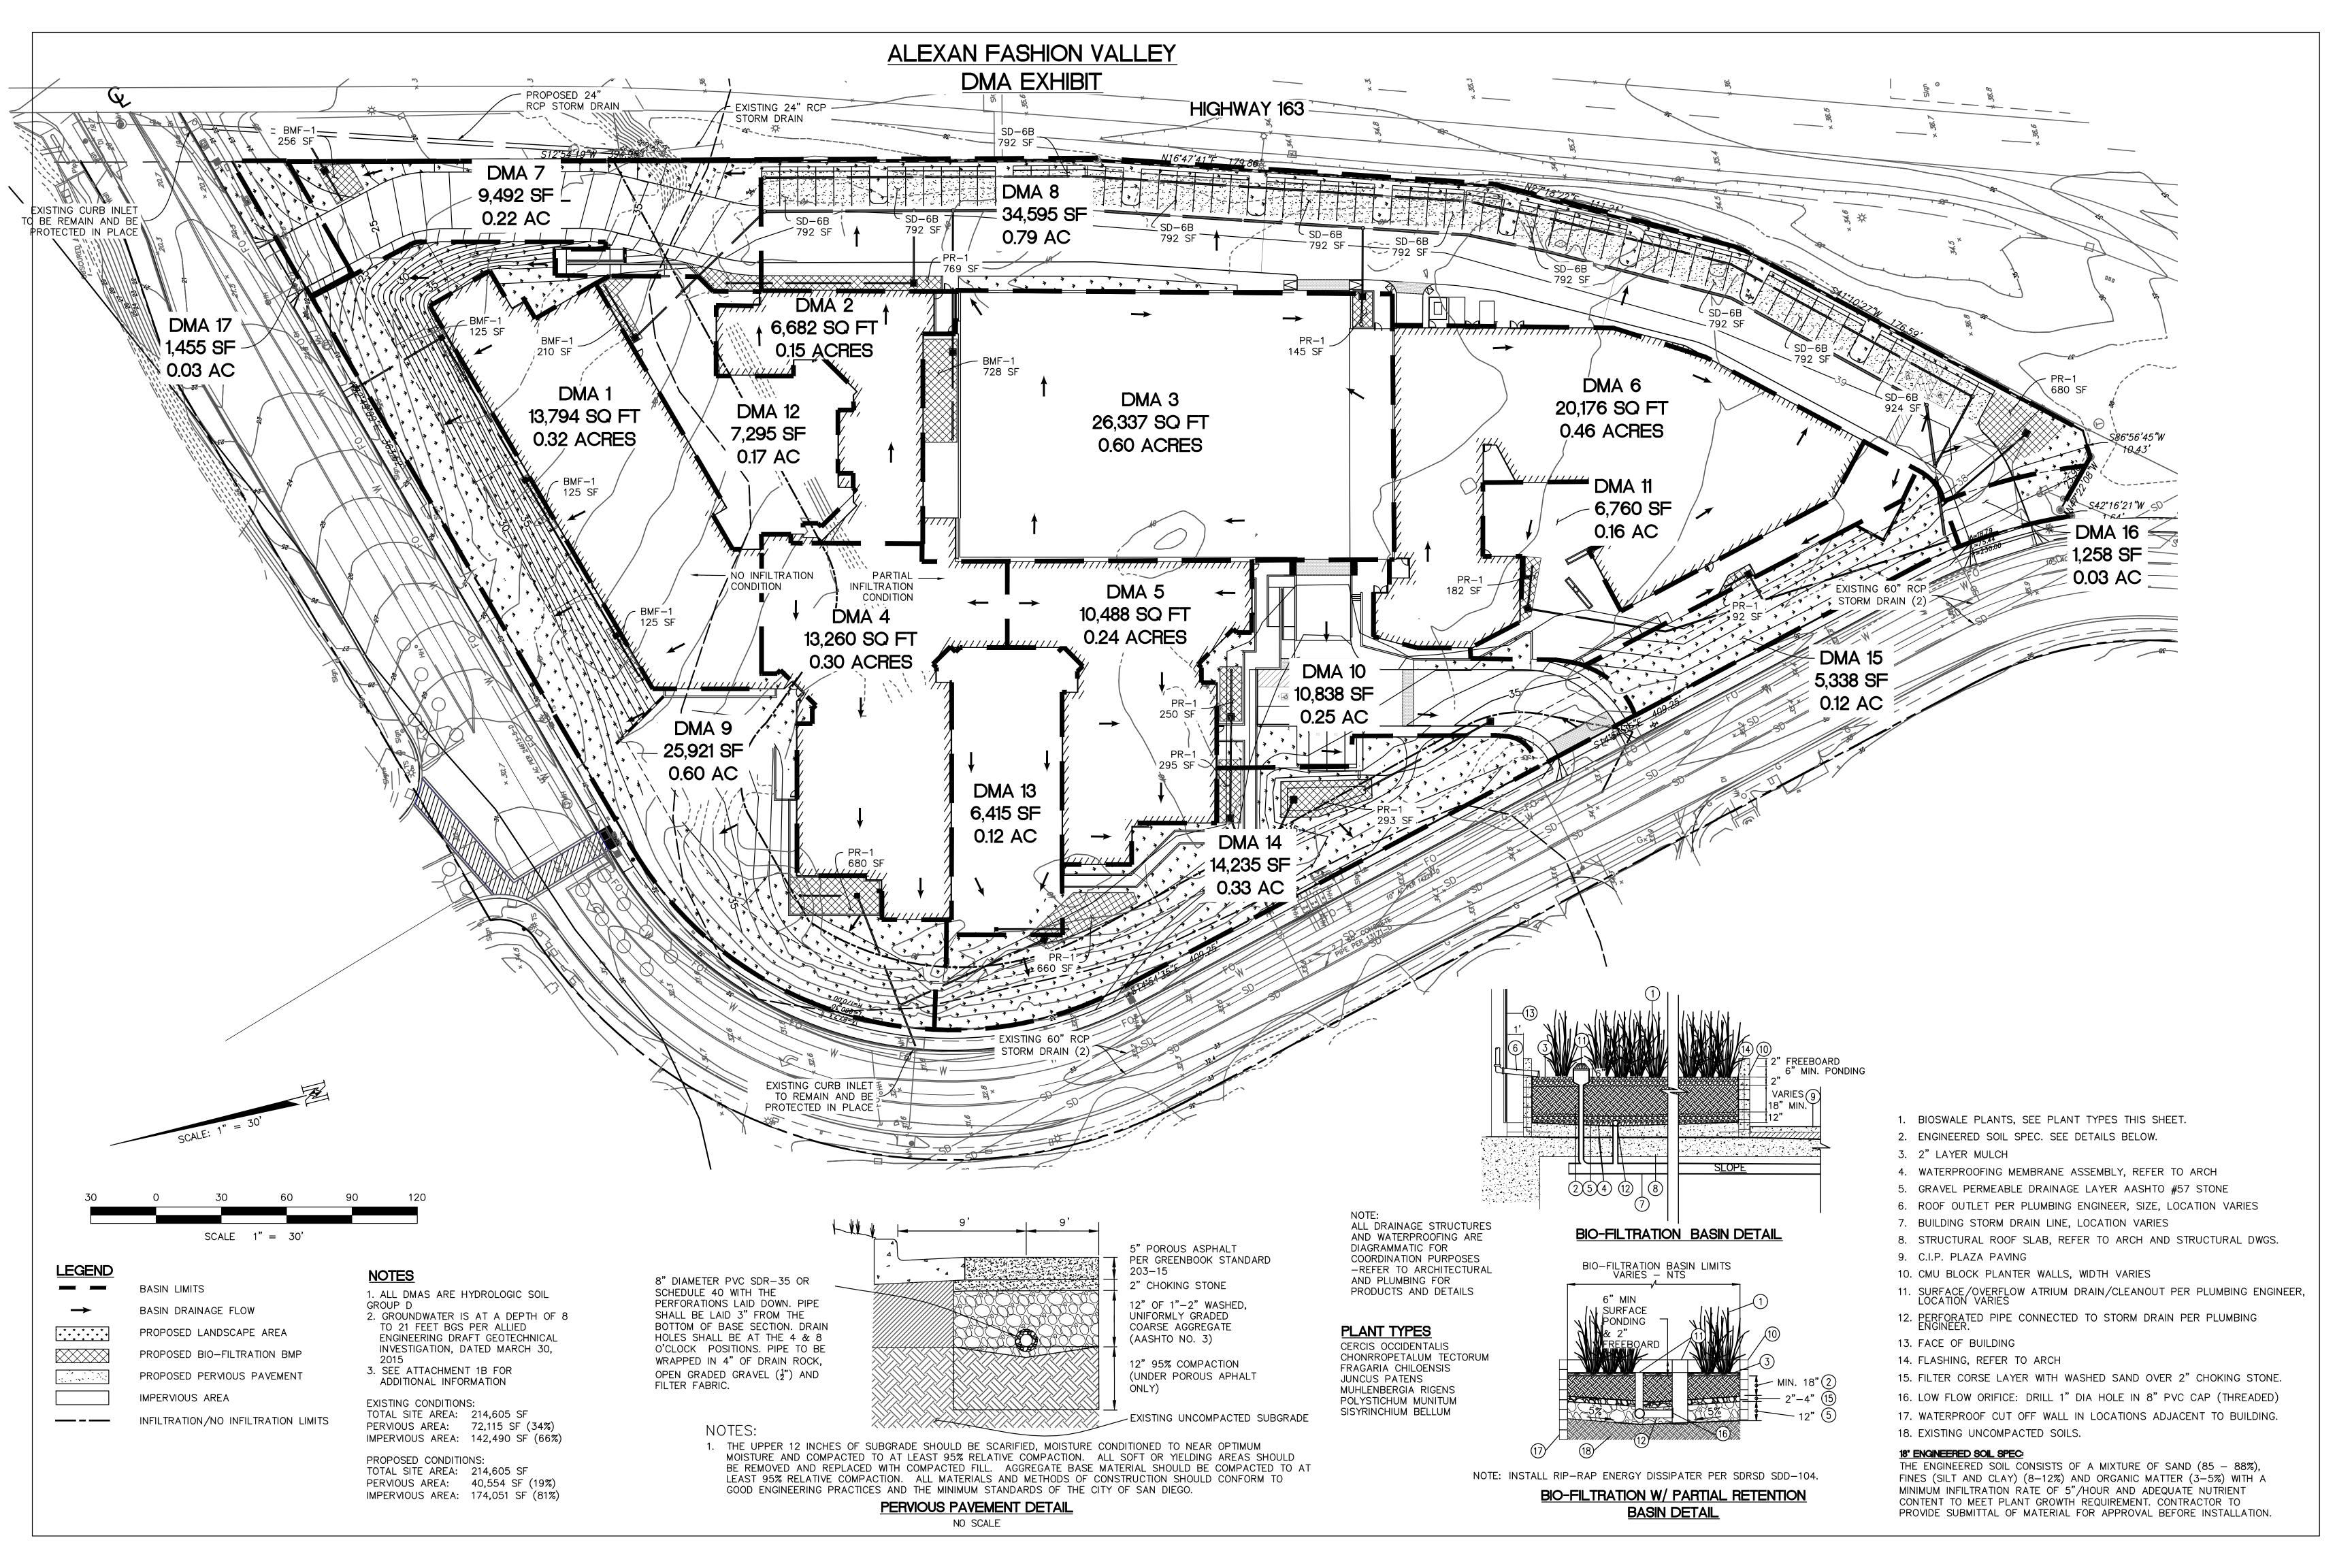
☑ Underlying hydrologic soil group
☑ Approximate depth to groundwater
☑ Existing natural hydrologic features (watercourses, seeps, springs, wetlands)
☐ Critical coarse sediment yield areas to be protected
☑ Existing topography and impervious areas
☑ Existing and proposed site drainage network and connections to drainage offsite
☑ Proposed grading
☑ Proposed impervious features
☑ Proposed design features and surface treatments used to minimize imperviousness
☑ Drainage management area (DMA) boundaries, DMA ID numbers, and DMA areas (square footage or acreage), and DMA type (i.e., drains to BMP, self-retaining, or self-mitigating)
☐ Potential pollutant source areas and corresponding required source controls (see Chapter 4, Appendix E.1, and Form I-3B)
☑ Structural BMPs (identify location, type of BMP, and size/detail)

The DMA Exhibit must identify:

Attachment Sequence	Contents	Checklist
Attachment 1a	DMA Exhibit (Required)  See DMA Exhibit Checklist.	
Attachment 1b	Tabular Summary of DMAs Showing DMA ID matching DMA Exhibit, DMA Area, and DMA Type (Required)*  *Provide table in this Attachment OR on DMA Exhibit in Attachment 1a	☐ Included on DMA Exhibit in Attachment 1a ☐ Included as Attachment 1b, separate from DMA Exhibit
Attachment 1c	Form I-7, Harvest and Use Feasibility Screening Checklist (Required unless the entire project will use infiltration BMPs)  Refer to Appendix B.3-1 of the BMP Design Manual to complete Form I-7.	<ul> <li>✓ Included</li> <li>☐ Not included because the entire project will use infiltration BMPs</li> </ul>
Attachment 1d	Form I-8, Categorization of Infiltration Feasibility Condition (Required unless the project will use harvest and use BMPs)  Refer to Appendices C and D of the BMP Design Manual to complete Form I-8.	☐ Not included because the entire project will use harvest and use BMPs

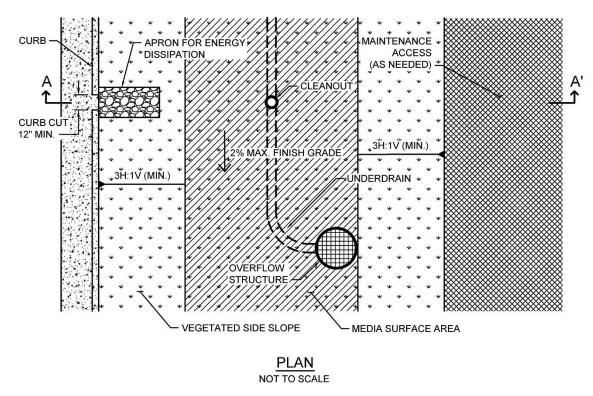
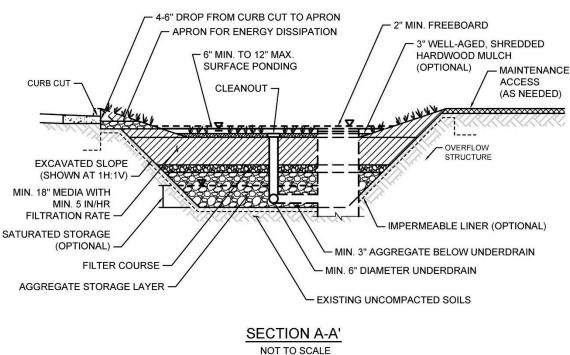
Figure E.13-E.13-1: Typical plan and Section view of a Biofiltration BMP

- Inflow distribution mechanisms (e.g, perimeter flow spreader or filter strips)
- Energy dissipation mechanism for concentrated inflows (e.g., splash blocks or riprap)
- Shallow surface ponding for captured flows
- Side slope and basin bottom vegetation selected based on expected climate and ponding depth
- Non-floating mulch layer
- Media layer (planting mix or engineered media) capable of supporting vegetation growth
- Filter course layer (aka choking layer) consisting of aggregate to prevent the migration of fines into uncompacted native soils or the aggregate storage layer
- Aggregate storage layer with underdrain(s)
- Impermeable liner or uncompacted native soils at the bottom of the facility
- Overflow structure

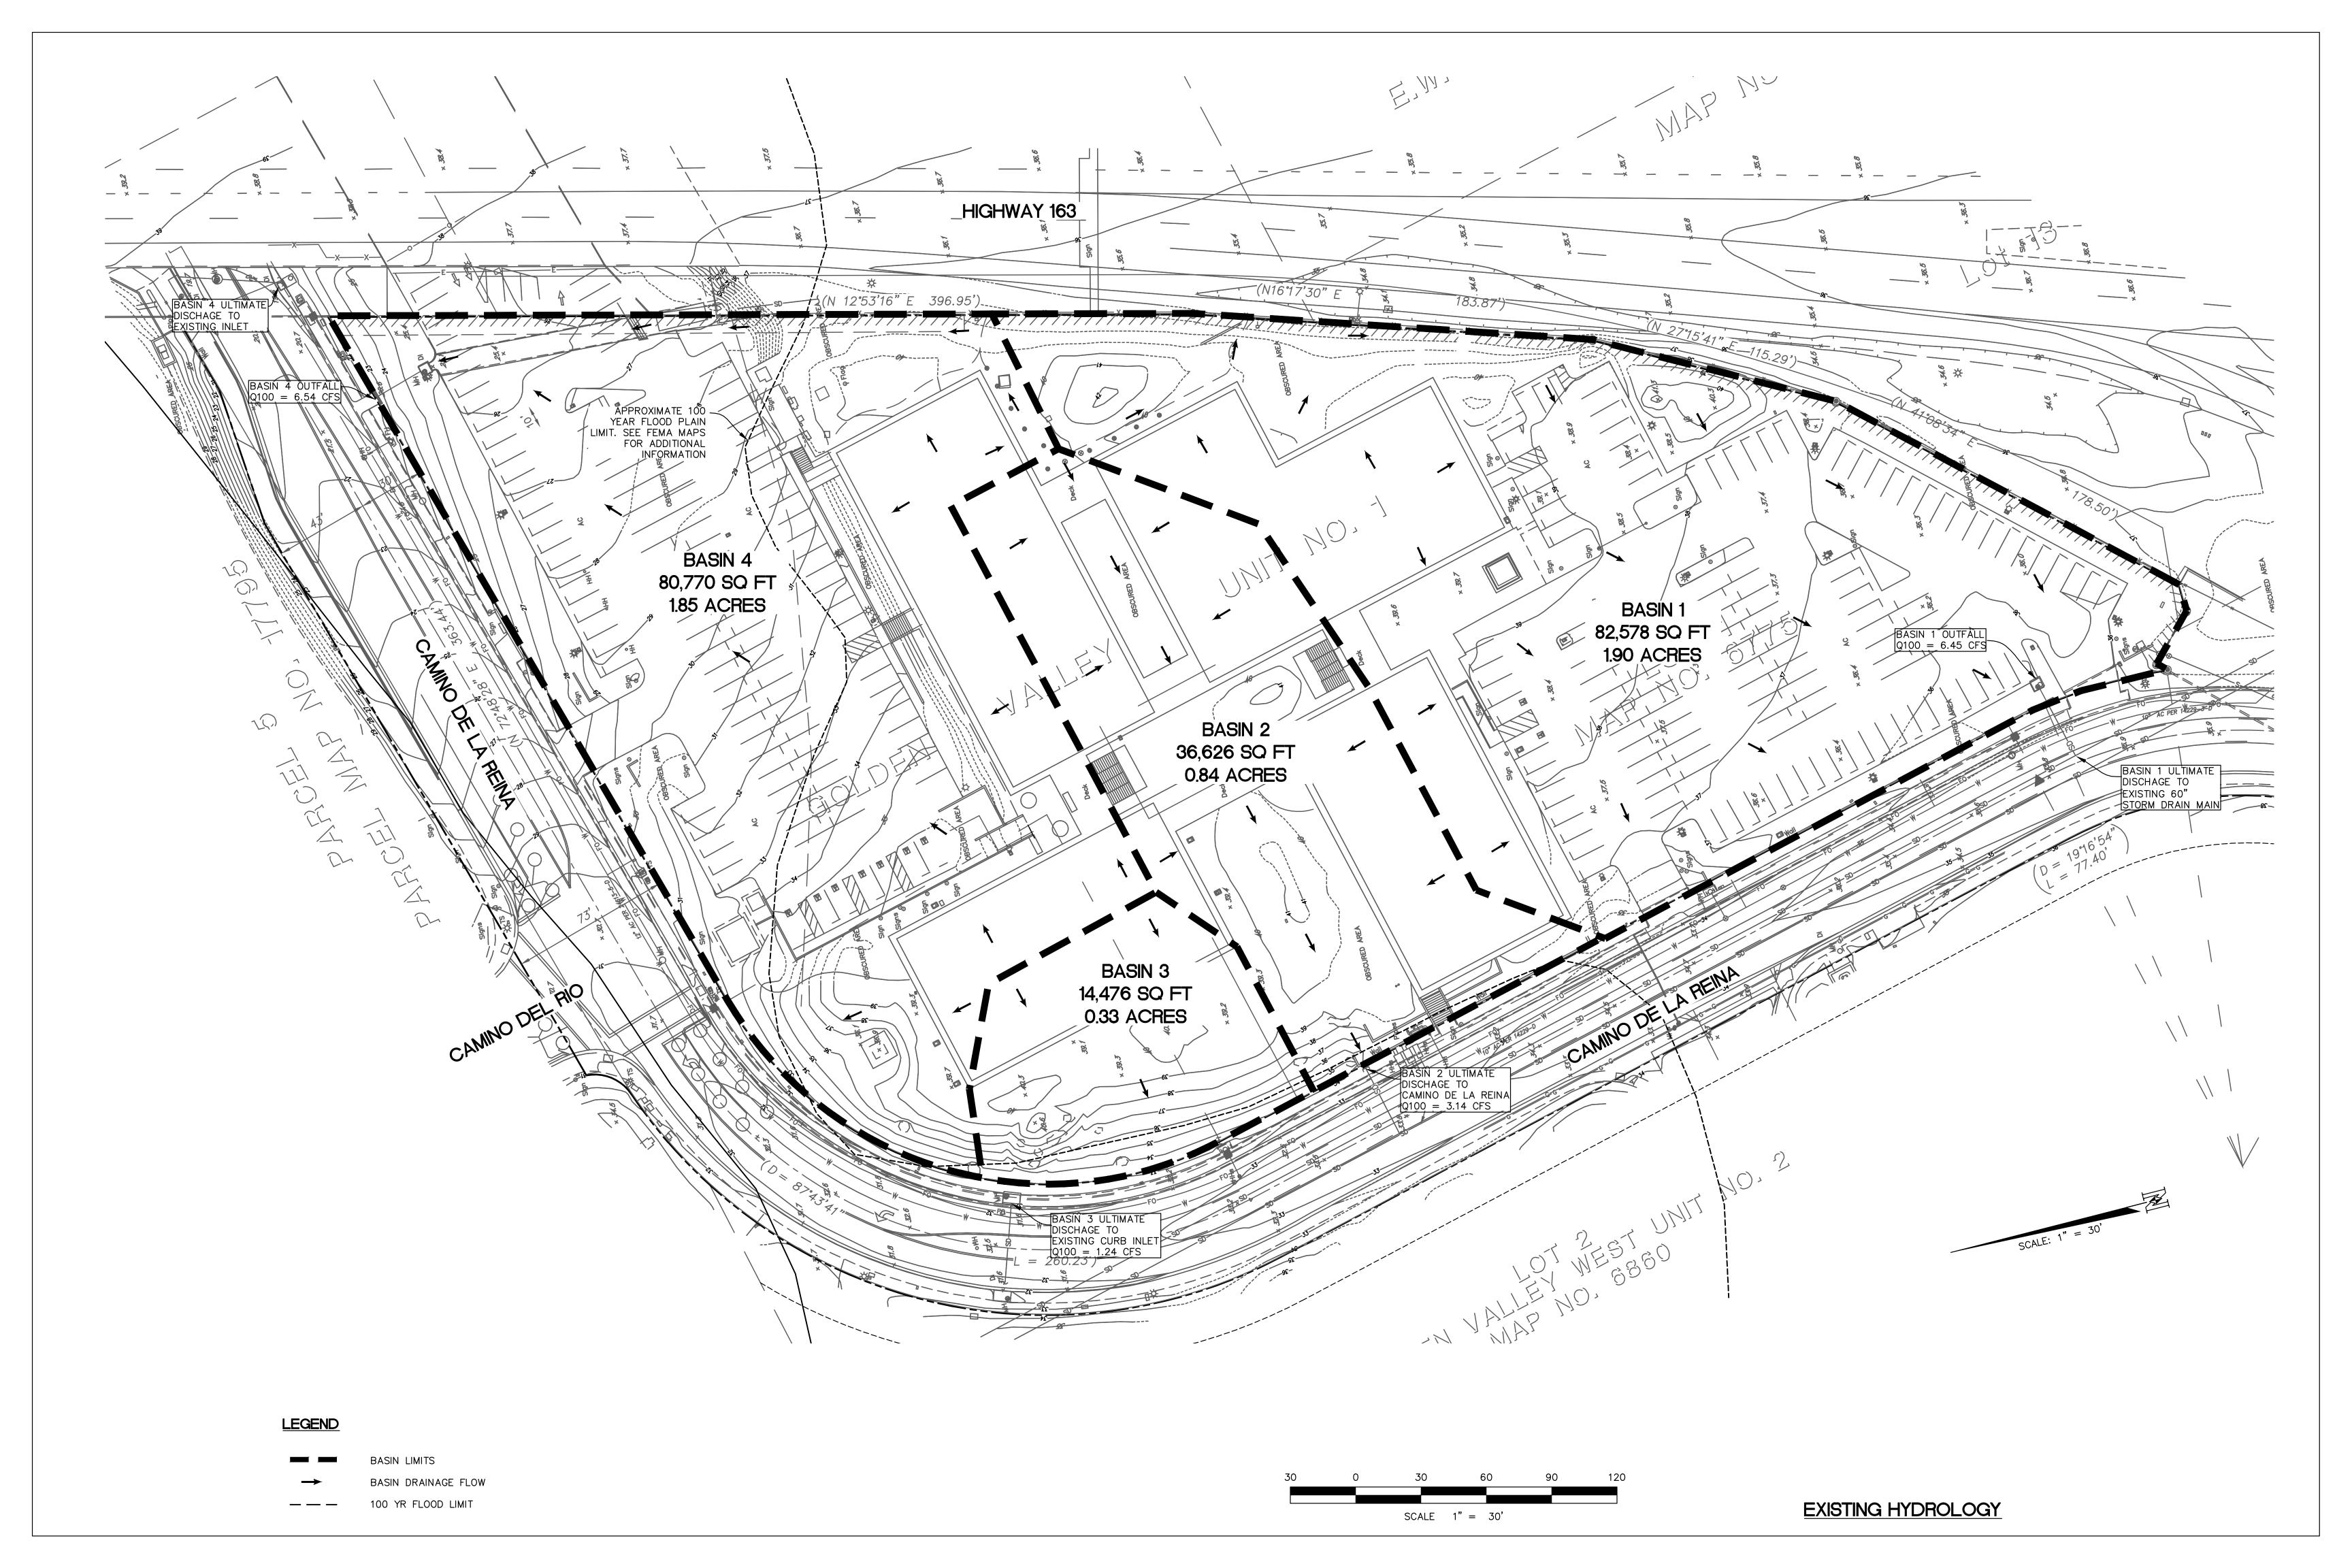
## **Existing Hydrologic Conditions**

## APPENDIX A

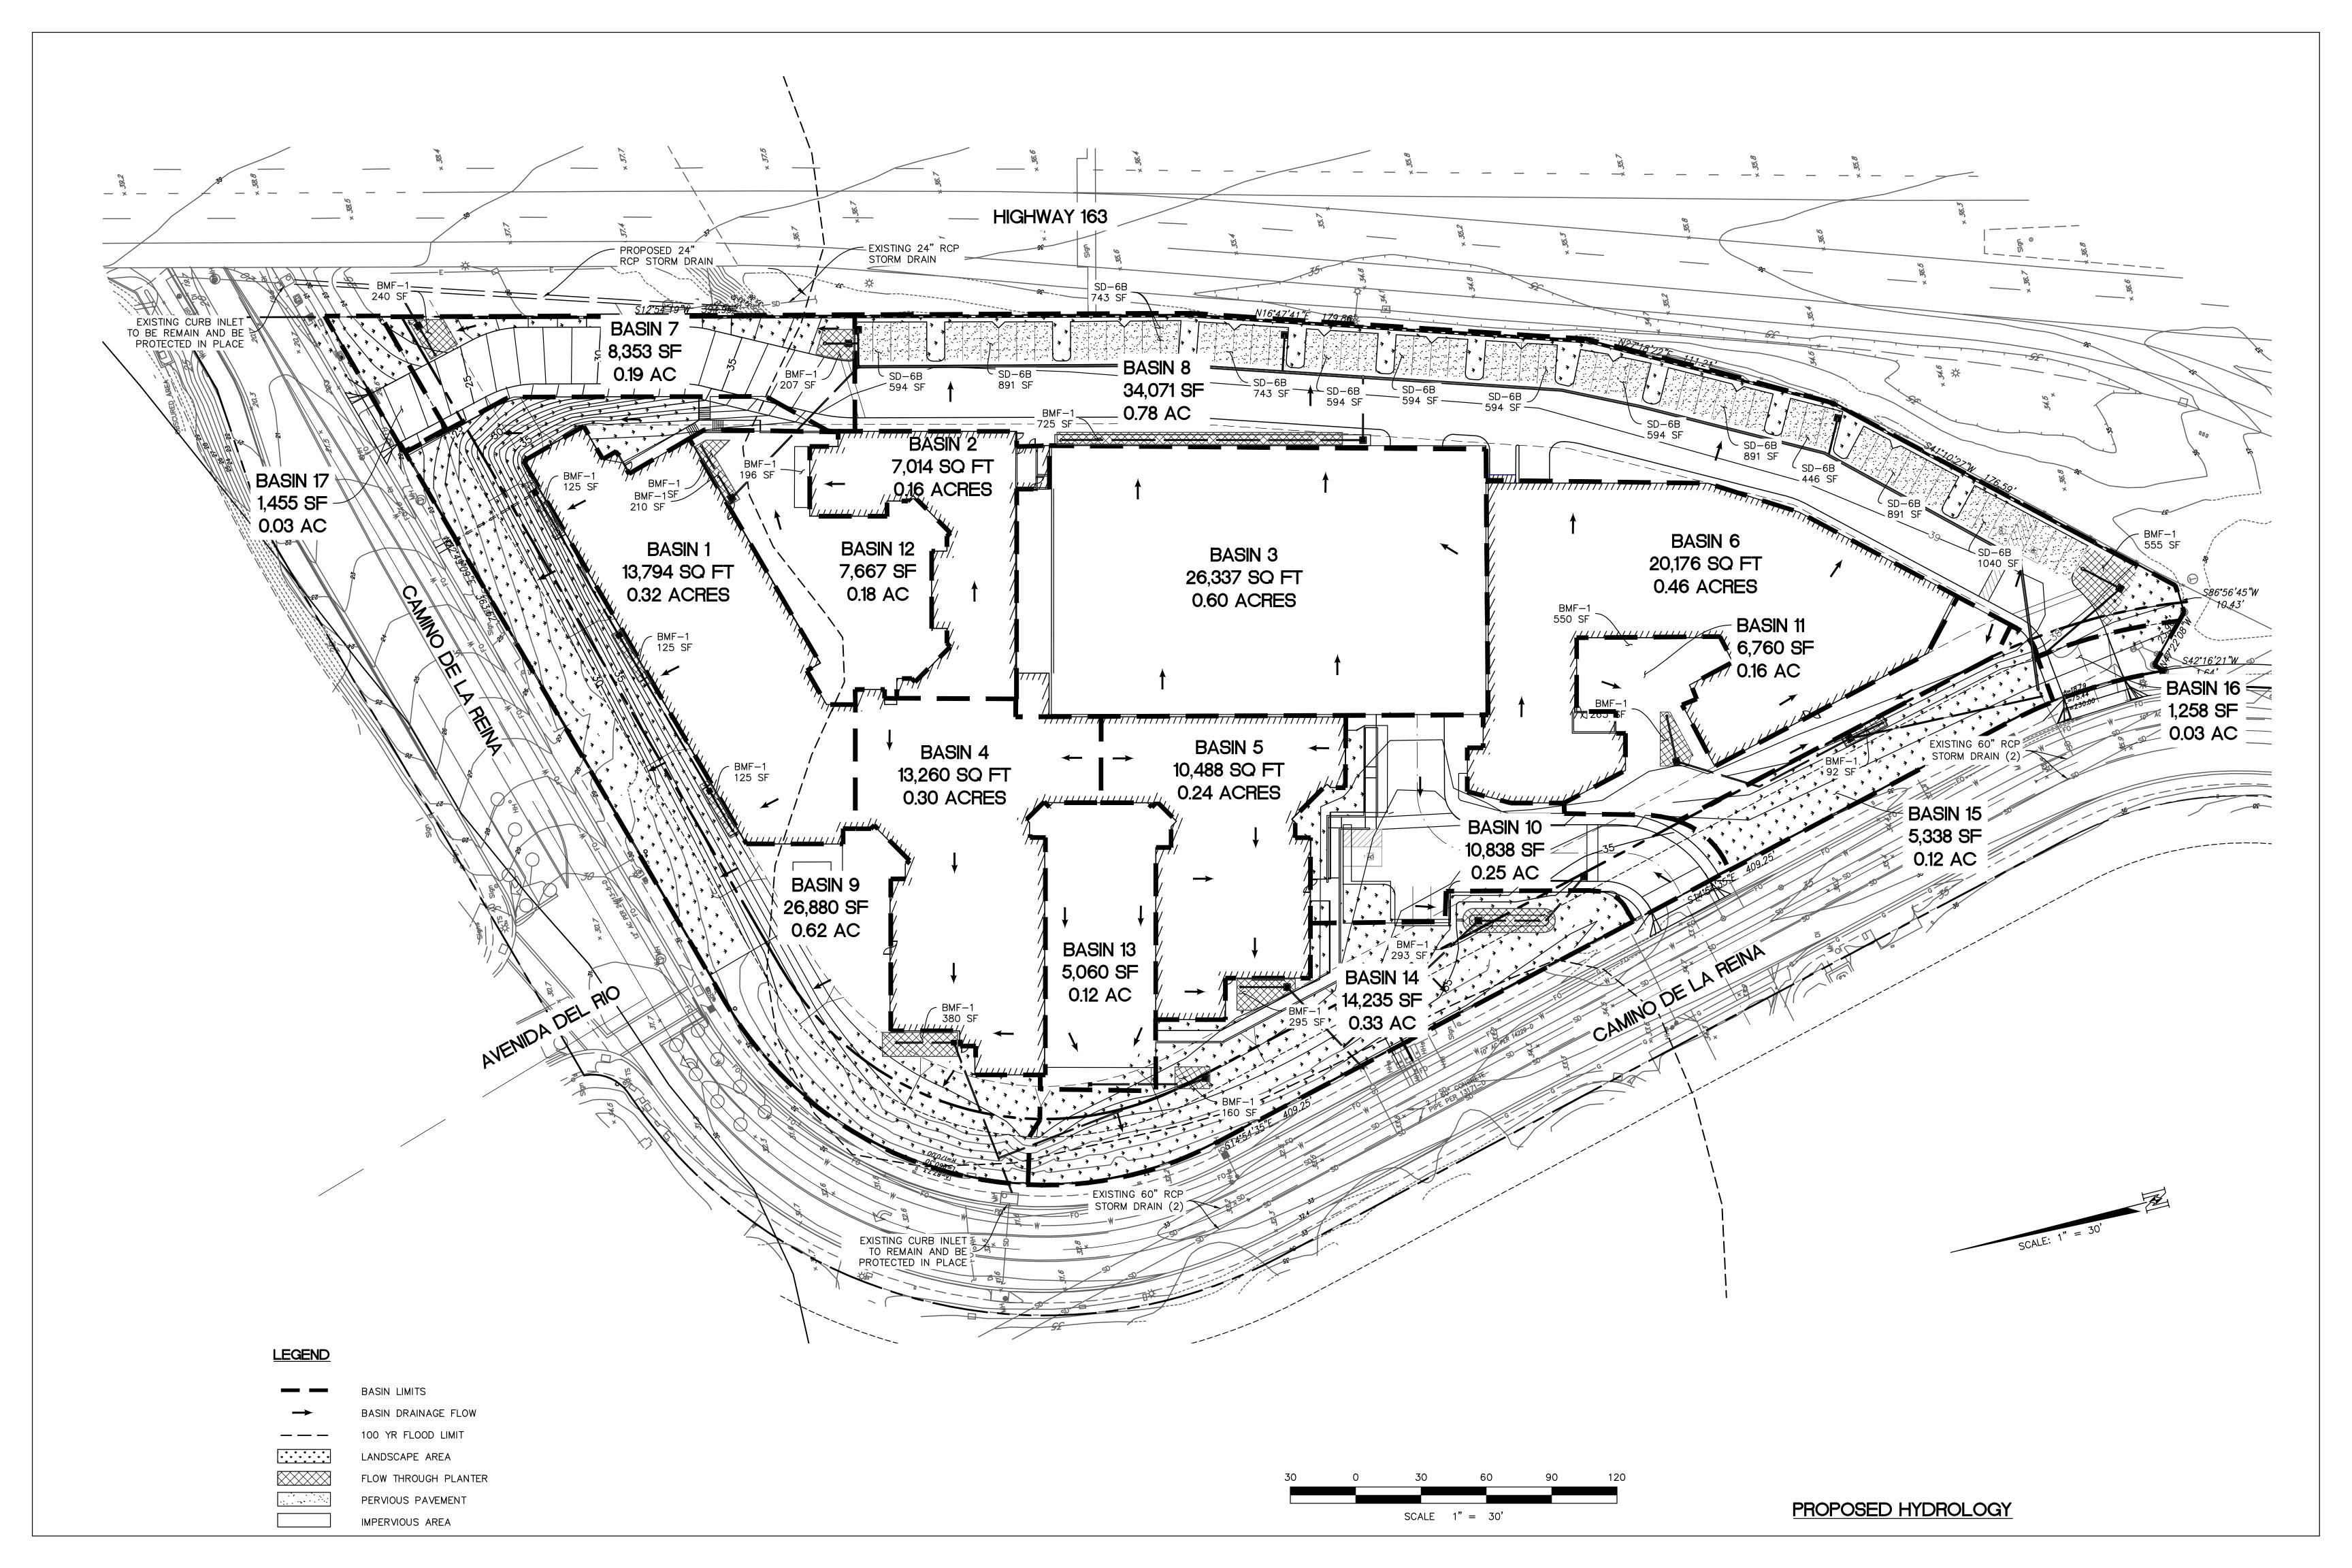
## **Proposed Hydrologic Conditions**

## APPENDIX B

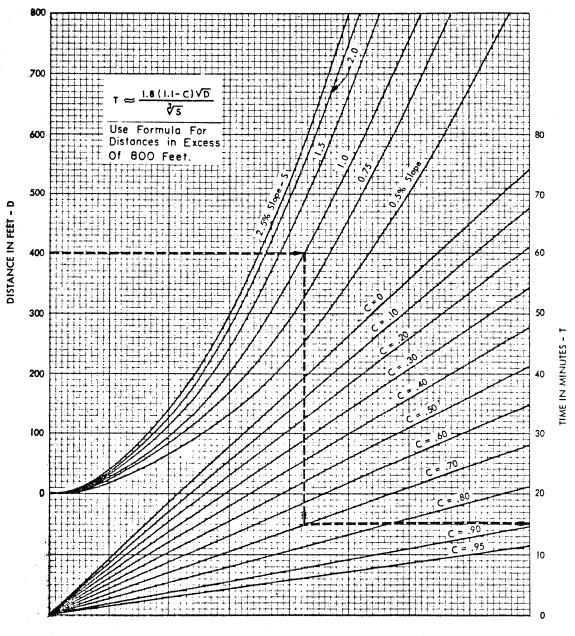
# URBAN AREAS OVERLAND TIME OF FLOW CURVES

Surface Flow Time Curves

COEFFICIENT OF RUNOFF C = .70

READ: OVERLAND FLOWTIME = 15 MINUTES

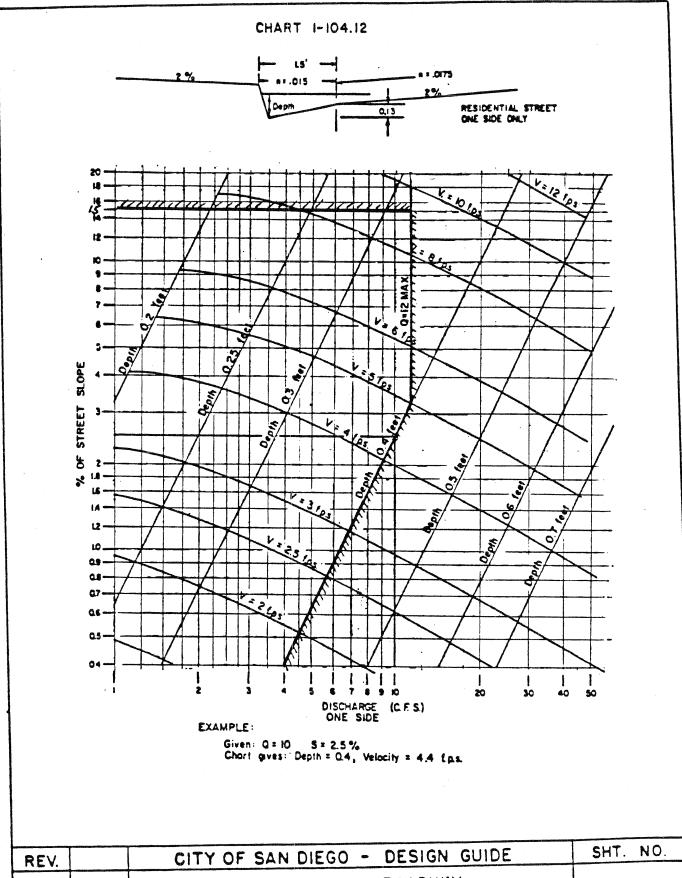
REV.	CITY OF SAN DIEGO - DESIGN GUIDE	SHT. NO.
	GUTTER AND ROADWAY	
·	DISCHARGE - VELOCITY CHART

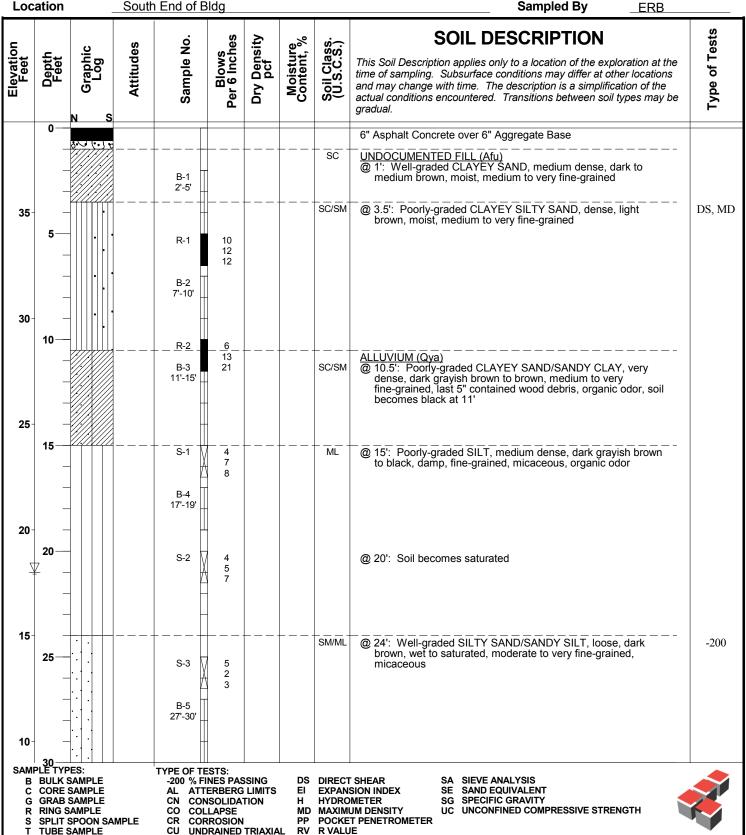
Project No. 2-25-15 10949.001 **Date Drilled Project** Fashion Valley Logged By **ERB Drilling Co. Baja Exploration Hole Diameter** 8" **Drilling Method** Hollow Stem Auger - 140lb - Autohammer - 30" Drop **Ground Elevation** 39' Location South End of Bldg Sampled By

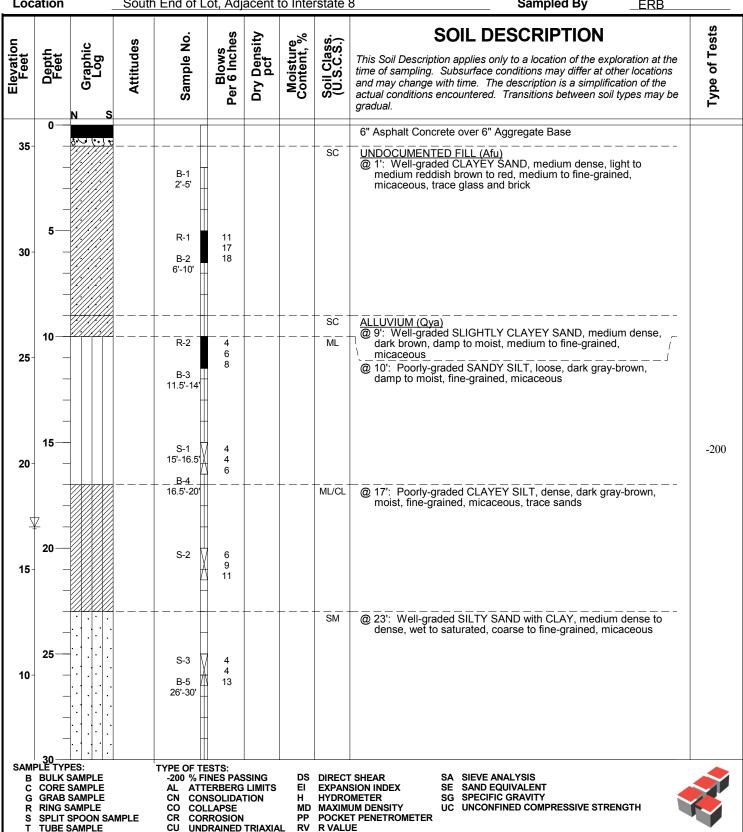
Project No. 2-25-15 10949.001 **Date Drilled Project** Fashion Valley Logged By **ERB Drilling Co. Baja Exploration Hole Diameter** 8" **Drilling Method** Hollow Stem Auger - 140lb - Autohammer - 30" Drop **Ground Elevation** 36' Location South End of Lot, Adjacent to Interstate 8 Sampled By **ERB**

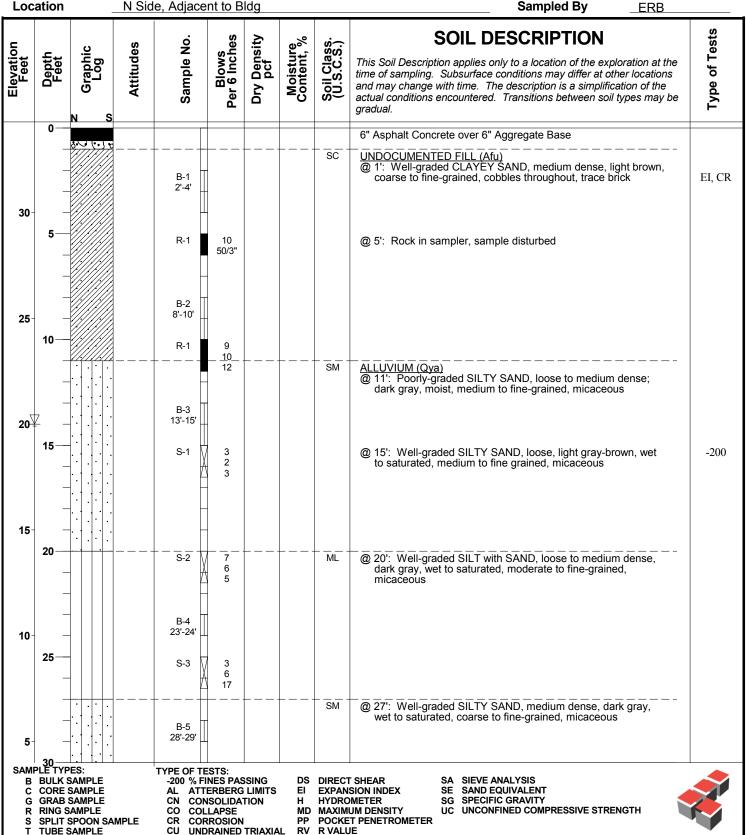
Project No. 2-25-15 10949.001 **Date Drilled Project** Fashion Valley Logged By **ERB Drilling Co. Baja Exploration Hole Diameter** 8" **Drilling Method** Hollow Stem Auger - 140lb - Autohammer - 30" Drop **Ground Elevation** 34' Location N Side, Adjacent to Bldg Sampled By

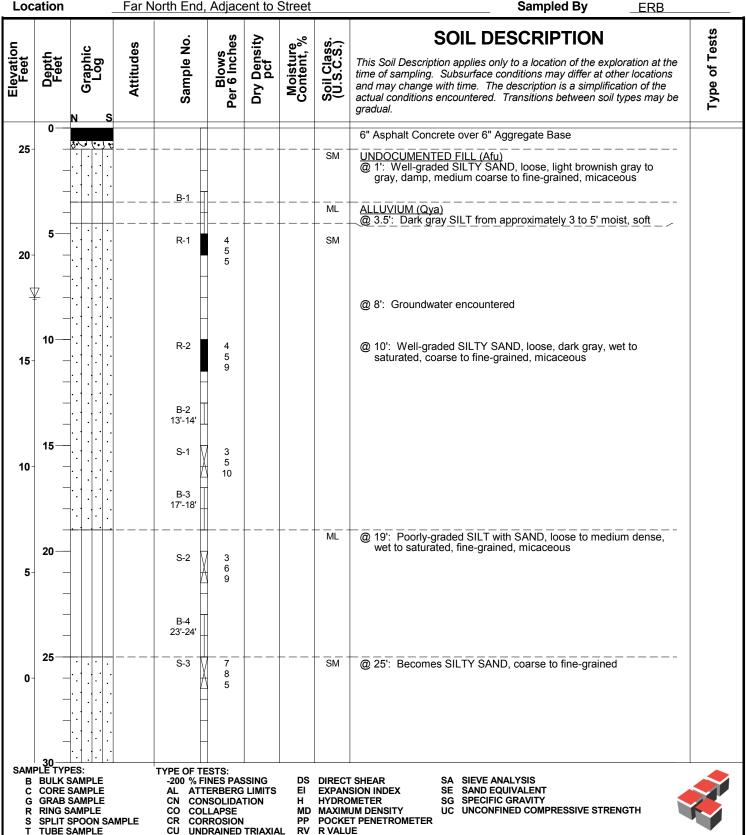
Project No. 2-25-15 10949.001 **Date Drilled Project** Fashion Valley Logged By **ERB Drilling Co. Baja Exploration Hole Diameter** 8" **Drilling Method** Hollow Stem Auger - 140lb - Autohammer - 30" Drop **Ground Elevation** 26' Location Far North End, Adjacent to Street Sampled By

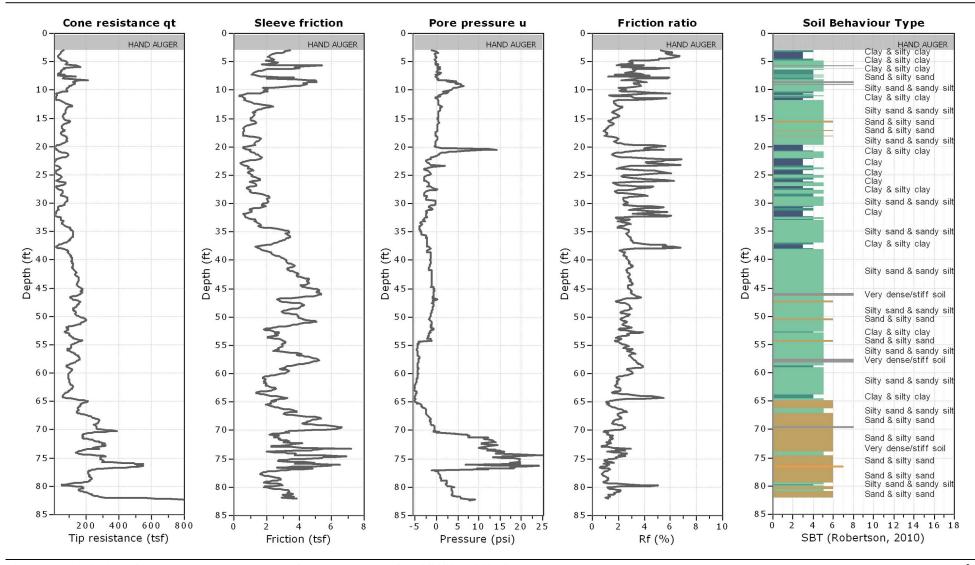
CPT: CPT-1

Total depth: 82.31 ft, Date: 2/25/2015

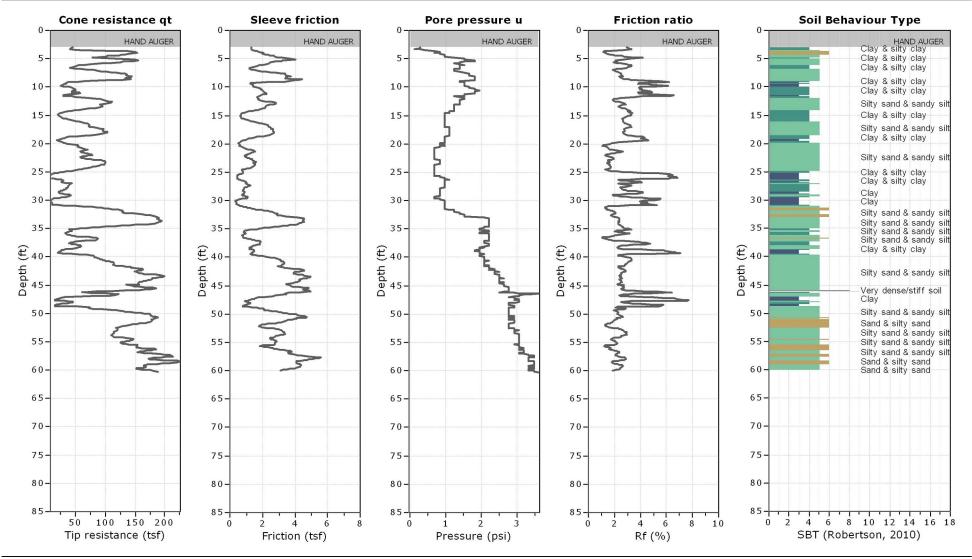
CPT: CPT-2

Total depth: 60.34 ft, Date: 2/25/2015

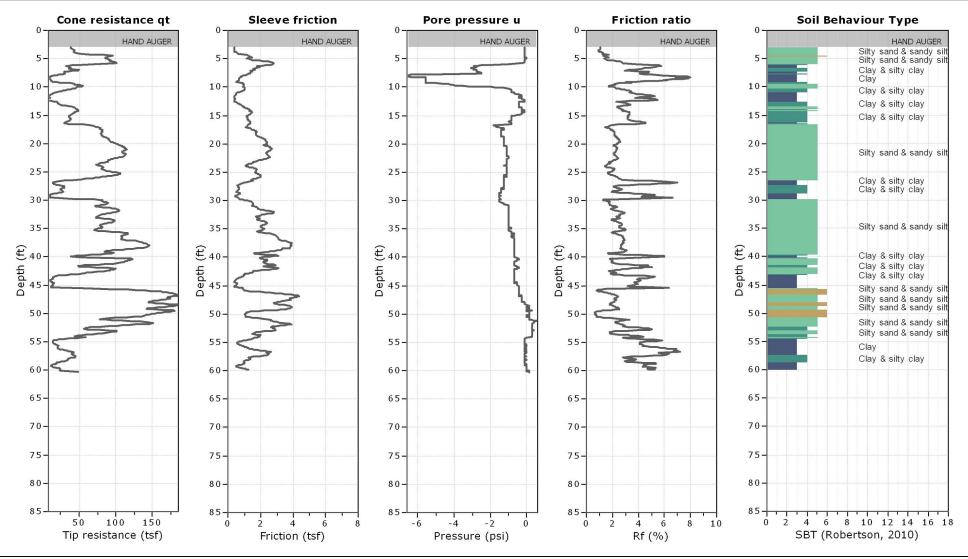
CPT: CPT-3

Total depth: 60.26 ft, Date: 2/25/2015

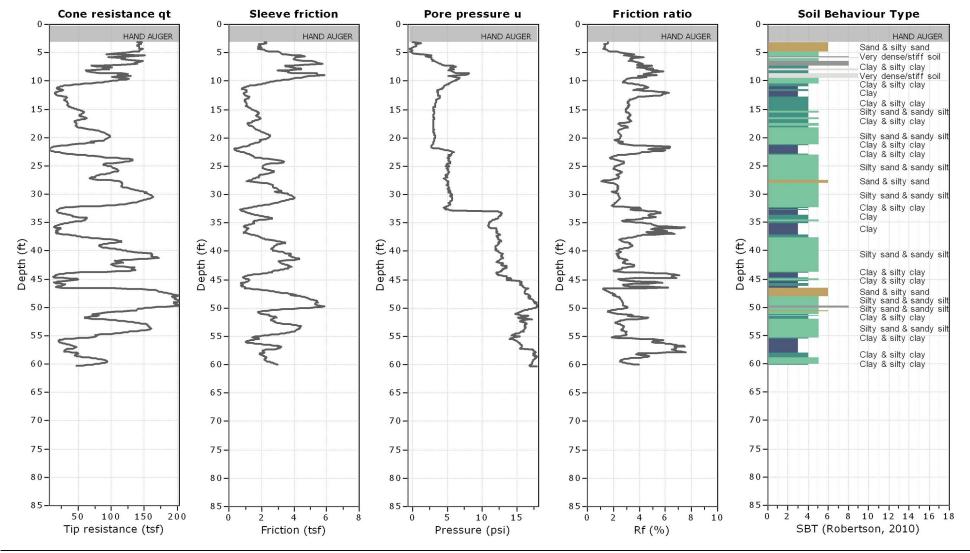
CPT: CPT-4

Total depth: 60.37 ft, Date: 2/25/2015

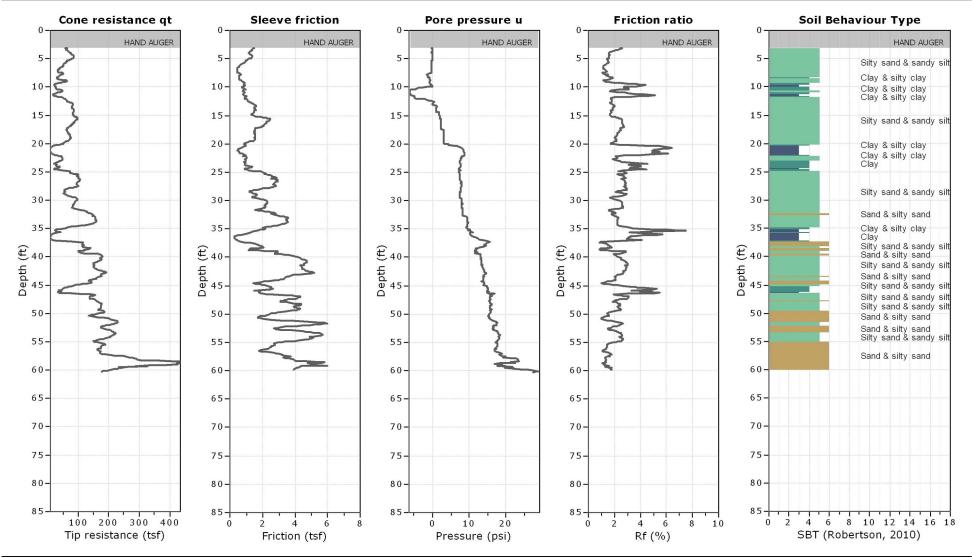
CPT: CPT-5

Total depth: 60.27 ft, Date: 2/25/2015

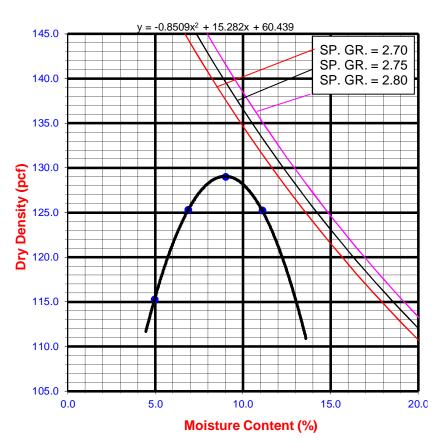
Preparation Method:	Moist	Moist X Mechanic			ınical Ram	
	X Dry	Dry			al Ram	
Mold Volume (ft		0.03308	Ram	Weight 10 L	BS Drop	18 inches
Moisture Ad	ded 0	50	100	150		
TEST NO.	1	2	3	4		
Wt. Comp. Soil + Mold (g)	3678	3872	3972	3950		
Wt. of Mold (g)	1862	1862	1862	1862		AS
Net Wt. of Soil (g)	1816	2010	2110	2088		REC'D
Wet Wt. of Soil + Cont. (g)	497.0	499.1	496.0	504.5		497.0
Dry Wt. of Soil + Cont. (g)	473.5	467.0	455.0	454.1		473.5
Wt. of Container (g)	0.0	0.0	0.0	0.0		0.0
Moisture Content (%)	5.0	6.9	9.0	11.1		5.0
Wet Density (pcf)	121.0	134.0	140.6	139.2		
Dry Density (pcf)	115.3	125.3	129.0	125.3

Maximum Dry Density (pcf) 129.0 Optimum Moisture Content (%) 9.0

Soil Passing 3/4 in. (19.0 mm) Sieve Mold: 6 in. (152.4 mm) diameter Layers: 5 (Five)
Blows per layer: 56 (fifty-six)
Use if +3/8 in. >25% and +¾ in. <30%

<u>Maximum Dry Density and Optimum Moisture Content Tests:</u> The maximum dry density and optimum moisture content of a selected representative soil sample was evaluated in general accordance with ASTM D 1557. The test results are presented on the attached figures.

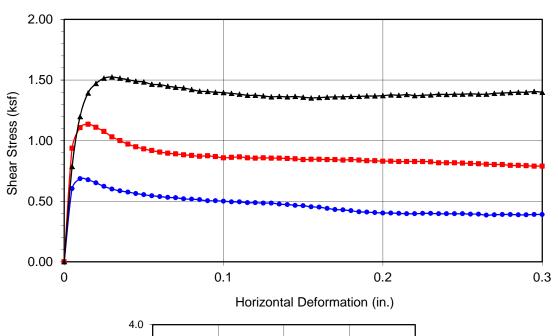
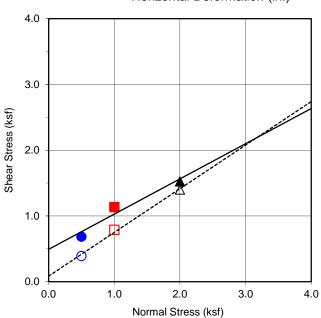
Boring No.	B-1			
Sample No.	B-1			
Depth (ft)	2.0-5.0			
Sample Type:	90% REMOLD			
Soil Identification: SM: REDDISH-BROWN SILTY SAND				
Strength Parameters				
0.4

SAND				
Strength Parameters				
C (psf) φ (°)				
Peak	490.0	28.2		
Ultimate	85.0	33.6

Normal Stress (kip/ft²)	0.500	1.000	2.000
Peak Shear Stress (kip/ft²)	0.685	<b>1.135</b>	▲ 1.525
Shear Stress @ End of Test (ksf)	<b>O</b> 0.390	<b>0.789</b>	△ 1.399
Deformation Rate (in./min.)	0.0500	0.0500	0.0500
Initial Sample Height (in.)	1.000	1.000	1.000
Diameter (in.)	2.415	2.415	2.415
Initial Moisture Content (%)	8.89	8.89	8.89
Dry Density (pcf)	116.4	116.3	116.3
Saturation (%)	53.5	53.5	53.5
Soil Height Before Shearing (in.)	0.9999	0.9940	0.9885
Final Moisture Content (%)	15.1	14.5	13.9

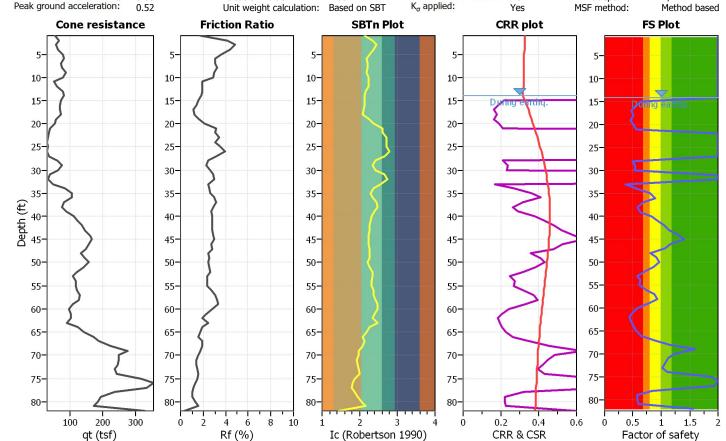
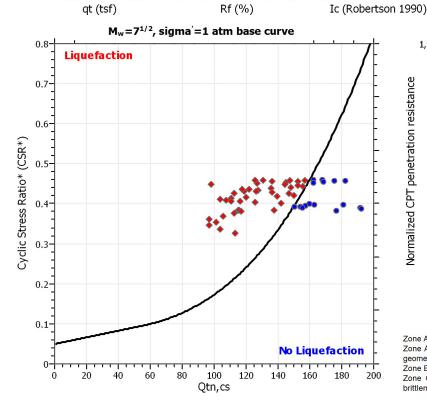
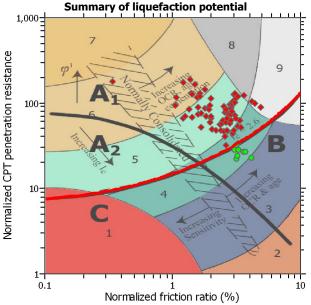
This software is licensed to: Leighton CPT name: CPT-1

Zone  $A_1$ : Cyclic liquefaction likely depending on size and duration of cyclic loading Zone  $A_2$ : Cyclic liquefaction and strength loss likely depending on loading and ground geometry

Zone B: Liquefaction and post-earthquake strength loss unlikely, check cyclic softening Zone C: Cyclic liquefaction and strength loss possible depending on soil plasticity, brittleness/sensitivity, strain to peak undrained strength and ground geometry

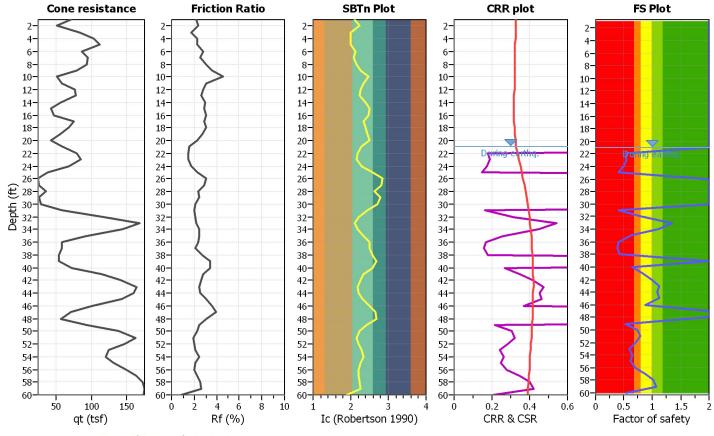
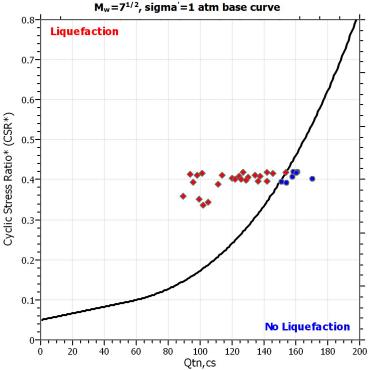
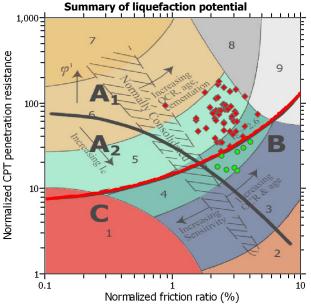
This software is licensed to: Leighton CPT name: CPT-2

Zone  $A_1$ : Cyclic liquefaction likely depending on size and duration of cyclic loading Zone  $A_2$ : Cyclic liquefaction and strength loss likely depending on loading and ground

Zone B: Liquefaction and post-earthquake strength loss unlikely, check cyclic softening Zone C: Cyclic liquefaction and strength loss possible depending on soil plasticity, brittleness/sensitivity, strain to peak undrained strength and ground geometry

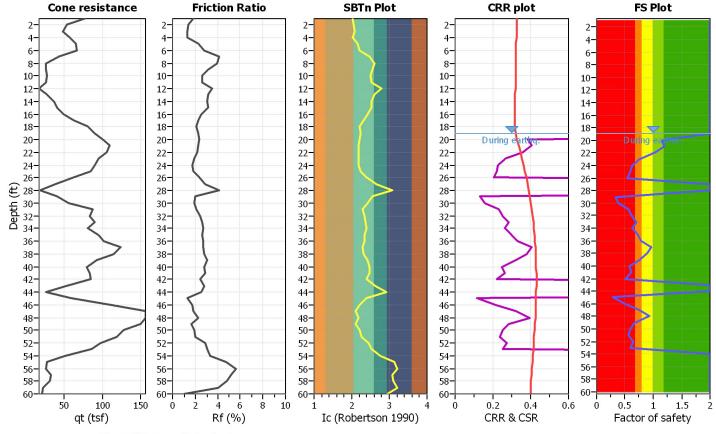
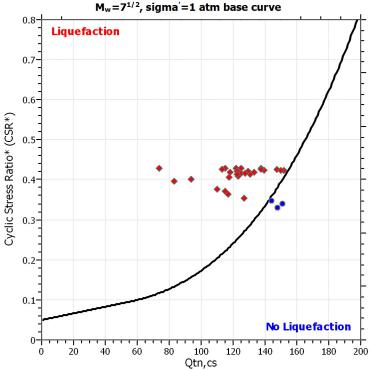
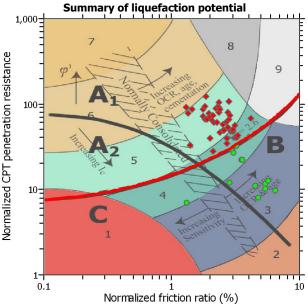
This software is licensed to: Leighton CPT name: CPT-3

Zone  $A_1$ : Cyclic liquefaction likely depending on size and duration of cyclic loading Zone  $A_2$ : Cyclic liquefaction and strength loss likely depending on loading and ground

Zone B: Liquefaction and post-earthquake strength loss unlikely, check cyclic softening Zone C: Cyclic liquefaction and strength loss possible depending on soil plasticity, brittleness/sensitivity, strain to peak undrained strength and ground geometry

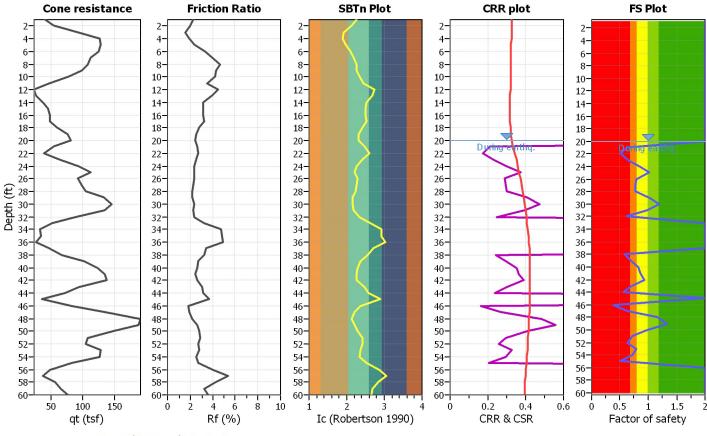
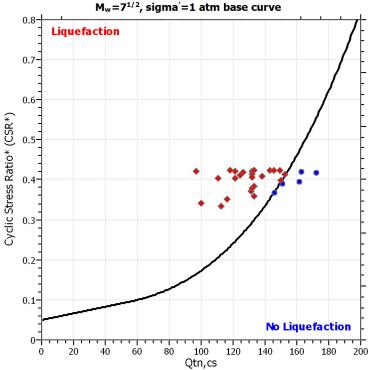
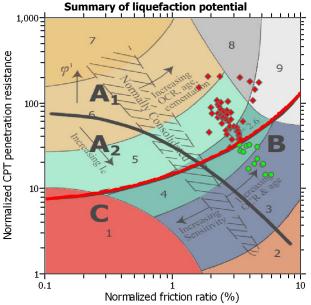
This software is licensed to: Leighton CPT name: CPT-4

Zone  $A_1$ : Cyclic liquefaction likely depending on size and duration of cyclic loading Zone  $A_2$ : Cyclic liquefaction and strength loss likely depending on loading and ground geometry

Zone B: Liquefaction and post-earthquake strength loss unlikely, check cyclic softening Zone C: Cyclic liquefaction and strength loss possible depending on soil plasticity, brittleness/sensitivity, strain to peak undrained strength and ground geometry
